MUNICIPAL FACILITIES COMMITTEE AGENDA

To: Andrew Merges, PE – City of Des Moines
From: Charles Conway
Date: 1/16/2015
Re: S 239th Street Stairs – Access Stair Replacement
Project No: 13136W2

CITY OF DES MOINES
 239TH ST STAIR AND STORMWATER ASSESSMENT
 Platform Repairs

SOUTH 239TH STAIR ASSESSMENT
MUNICIPAL FACILITIES COMMITTEE
JANUARY 28TH, 2016

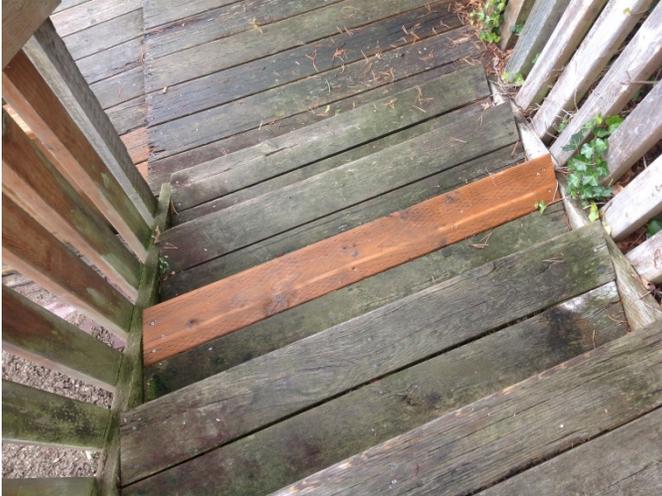
2. Splitting of the treads:

Many of the treads have split or begun to split at the ends where they are nailed to the side stringers. This splitting has the effect of rendering the end fasteners ineffective. Several of the most deteriorated treads have been replaced with new pressure-treated lumber.

Replacement Tread

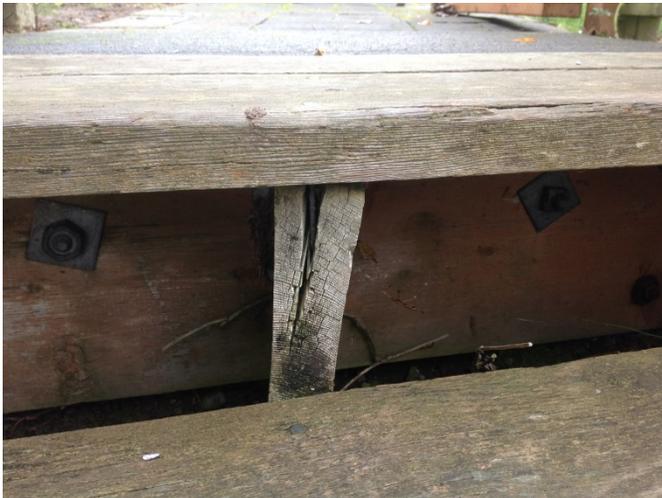
3. Splitting of the stringers:

Many of the stair tread support stringers have split or begun to split where they are penetrated by the stair tread fasteners. This splitting has the effect of weakening the support stringer and rendering the stair tread fasteners ineffective. In some locations, pressure-treated dimensional lumber blocking has been face-nailed to the side of the stringers to provide new connecting points for replacement treads.

Split Support Stringer

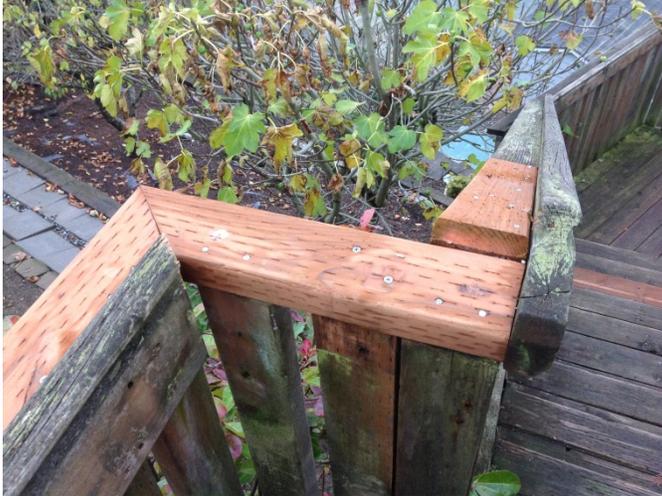
4. Guard top stringer deterioration:

The guard top stringers exhibit severe surface weathering and localized splitting in the way of the fasteners.

Replaced Top Stringers

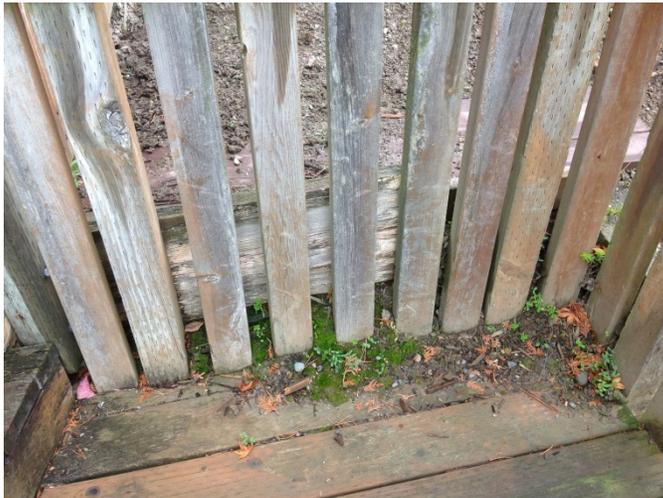
5. Accumulated soil against the structure:

Sloughing of the steep unprotected slope has resulted in an accumulation of soil against the upper surfaces of the timber structure, including the side skirts and lower surfaces of the guards.

Soil Accumulation against Guard

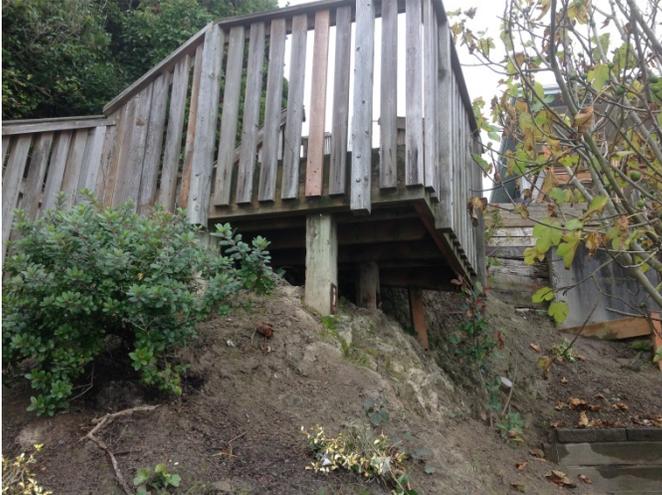
6. Subsidence of slope at support post locations:

The structure shows evidence of subsidence, particularly at the third landing from the top, where the structure is cantilevered over an area of nearly vertical terrain. An additional support post has been added in this area to attempt to arrest further sagging of the landing.

Location of Subsiding Post Foundations

KPG concurs with the City of Des Moines that the condition of the wood-frame access stairs and the timber-frame platform pose a significant risk of injury to the public. KPG recommends that the stairs remain closed until remedial actions can be undertaken. We further recommend that temporary shoring of the third landing from the top of the stair be undertaken to prevent collapse of the stair landing until demolition can be undertaken.
