MUNICIPAL FACILITIES COMMITTEE AGENDA

To: Andrew Merges, PE – City of Des Moines
From: Charles Conway
Date: 1/16/2015
Re: S 239th Street Stairs – Access Stair Replacement
Project No: 13136W2

CITY OF DES MOINES
 239TH ST STAIR AND STORMWATER ASSESSMENT
 Platform Repairs

SOUTH 239TH STAIR ASSESSMENT
MUNICIPAL FACILITIES COMMITTEE
JANUARY 28TH, 2016

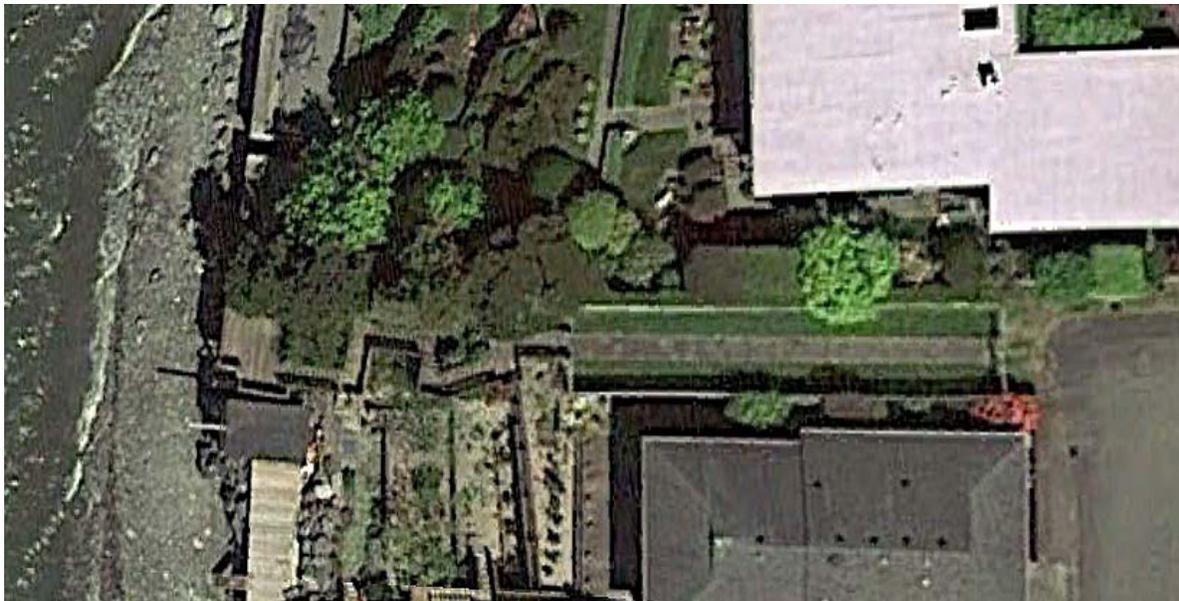
South 239th Street Beach Access

South 239th Street terminates at the intersection with 6th Avenue South approximately 145 feet east of the mean high water mark of Puget Sound. The City of Des Moines has maintained public access within the extended street right-of-way to a wood-frame viewing platform at the edge of the gravel beach. This access consists of a gently sloping concrete walkway extending 75 feet from the street end to the head of a wood-frame staircase which traverses steeply sloping terrain to reach the viewing platform.

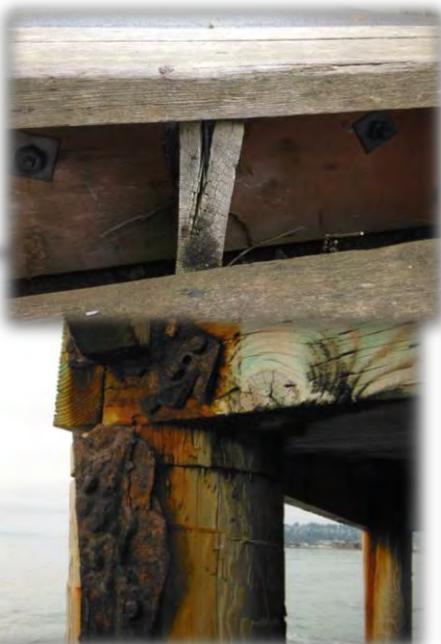
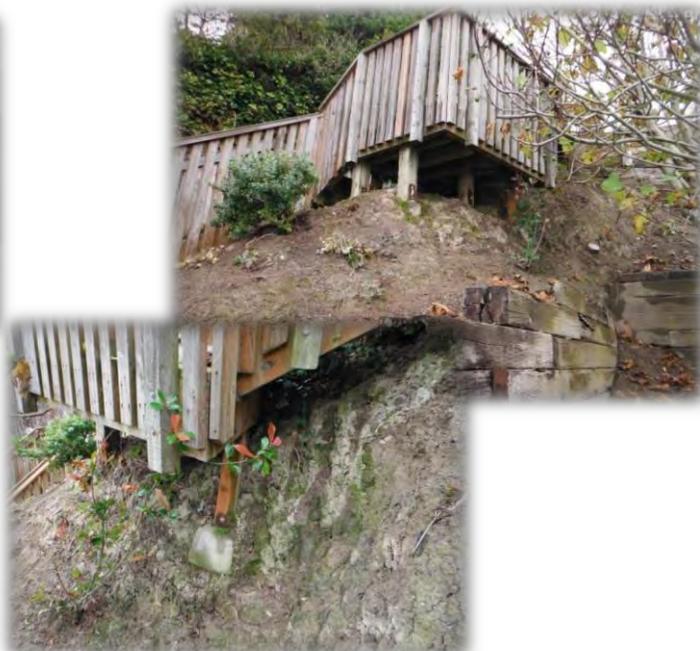
Timber Framed Platform

1. The timber framing, driven support pilings and concrete supporting bulkhead appear to be in serviceable condition, with an expected remaining structural service life of ten to fifteen years. The surface of the platform decking exhibits superficial weathering and algal growth, which renders the surface slippery in wet conditions.

2. Exposure to salt water and salt spray has caused significant damage to the connecting hardware. In most cases, the sacrificial zinc galvanizing coating has been completely eroded and the underlying steel components have corroded to the point of being unserviceable. In some cases the connecting hardware has failed completely and fallen away from the structure.

- Replace structural steel plates/connections to preserve the facility
- Total Project Cost = \$11,000 (If performed by City Crews)
